Reducing residual stress in 2014 aluminium alloy die forgings

D.A. Tanner^{*1,2} and J.S. Robinson^{1,3}

University of Limerick, Ireland.

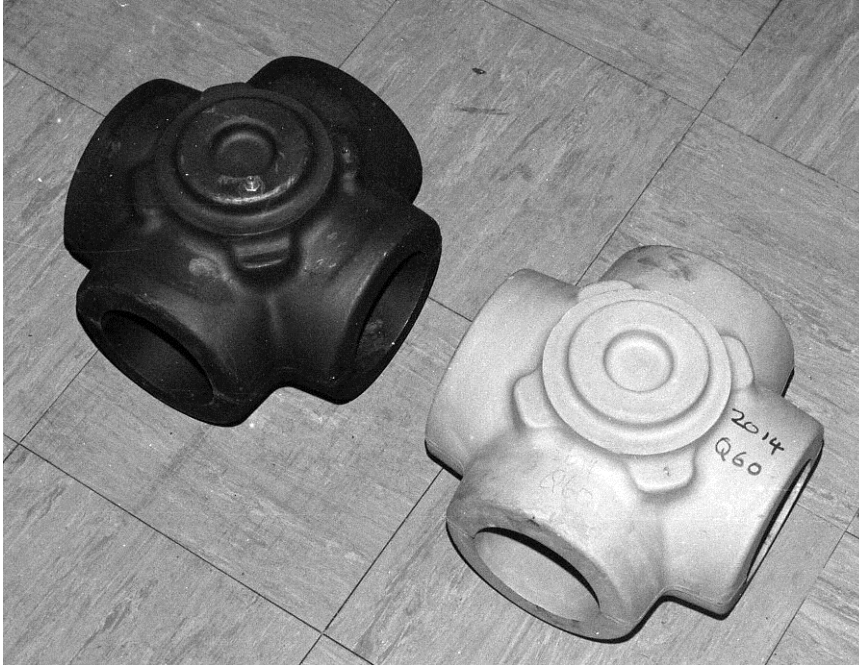
Figure 1 Example of hub forging with and without the black copper oxide residue

Hot caustic etching is carried out to remove residual forging lubricants after forming and leaves a black copper oxide powder residue on the surface of the part, an example of which is shown in Figure 1. It is normally removed immediately by immersing the forging in nitric acid prior to heat treatment, in a process known as 'de-smutting'. It is well known that not removing the black oxide coating increases the cooling rates during the quench, but the influence on residual stress magnitudes has not been determined.[4] It is expected that the residual stress magnitudes should be higher than for the standard boiling water quench given the faster cooling rates and increased thermal gradients.

Figure 1 Example of hub forging with and without the black copper oxide residue
